Burnaby Hospital High-Level Master Plan

Burnaby, British Columbia Final Draft – March 13, 2013 V-0

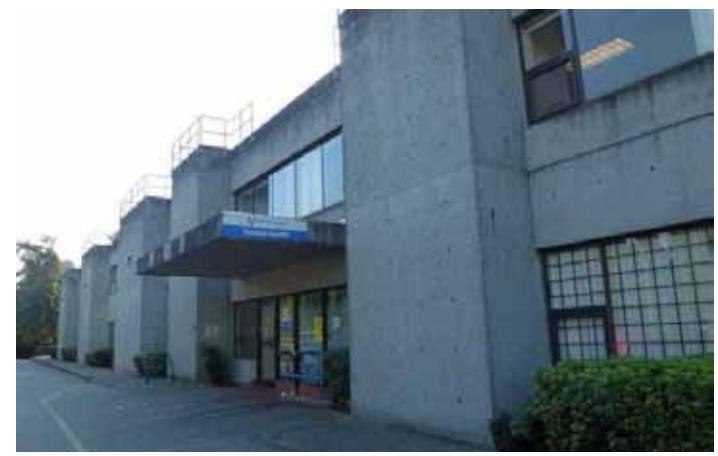
Figure 2: Cascade Residence North Entrance

"Overall the Cascade Building is in good condition with no evidence of distress or deterioration. The presence of critical structural weaknesses, as well as the insufficient LDRS capacity, deem this building to be significantly inadequate to meet the seismic provisions in the current code (only some 30-40% of capacity required)"

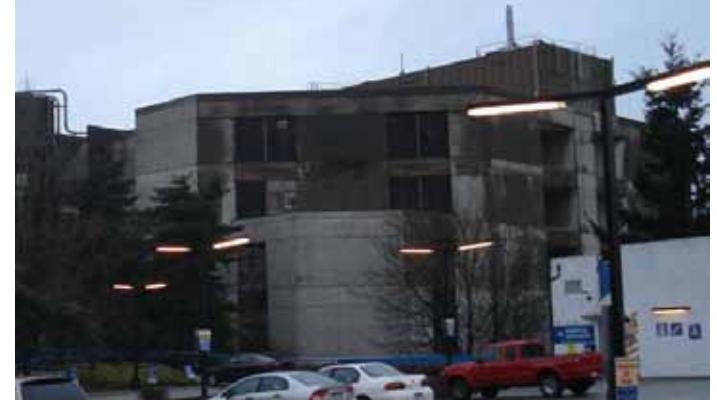
Figure 4: South-East Elevation Nursing Tower

The building is half set into the hill side with the East half of the structure supported on a pile foundation a full storey below the western half of the building. The piles are linked together with grade beams between pile caps. The west half of the building sits on conventional concrete strip and pad footings.
