Burnaby Hospital High-Level Master Plan

Burnaby, British Columbia Final Draft – March 13, 2013 V-0

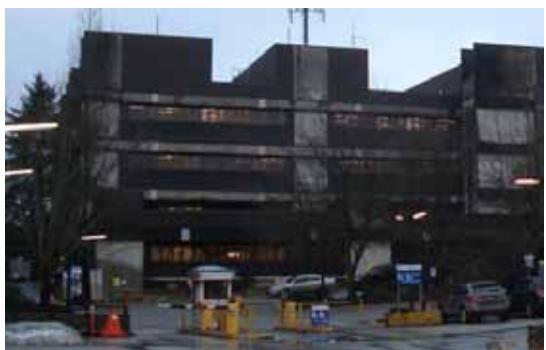
Figure 3: East Elevation Support Facilities Building

The Support Facility building is separated from the adjacent West Wing and Nursing Tower by 25 mm expansion joints. The expansion joint does not provide adequate distance to allow the buildings to move without pounding. Also, the expansion joint at the West Wing has a ledger angle that provides vertical support to the slab of the Support Facilities building. Excessive drifts that exceed the bearing width of the angle can lead to a loss of vertical support for the edge of the support facilities building at the joint.
